## WIDENING, STRENGTHENING AND REPAIR OF A MASONRY BRIDGE IN PONTECESO (GALICIA, SPAIN)

**Abstract.** *The paper summarizes the process of inspection, characterization of materials, assessment, project of the complete solution and the technical assistance to the execution of this masonry arch bridge. Special attention is given to the description the difficulties and boundary conditions of such a task, especially the durability of stones and the micro-piling of piers and abutments as a competitive solution to ensure the robustness of foundations, and insensitivity to scour, as well as rapidity of execution, avoiding under-water works. This bridge, which is included in the Catalogue of historical bridges of Galicia, has been widened, strengthened and repaired under the criteria of modern restoration recommendations and the principle of reversibility of intervention.*

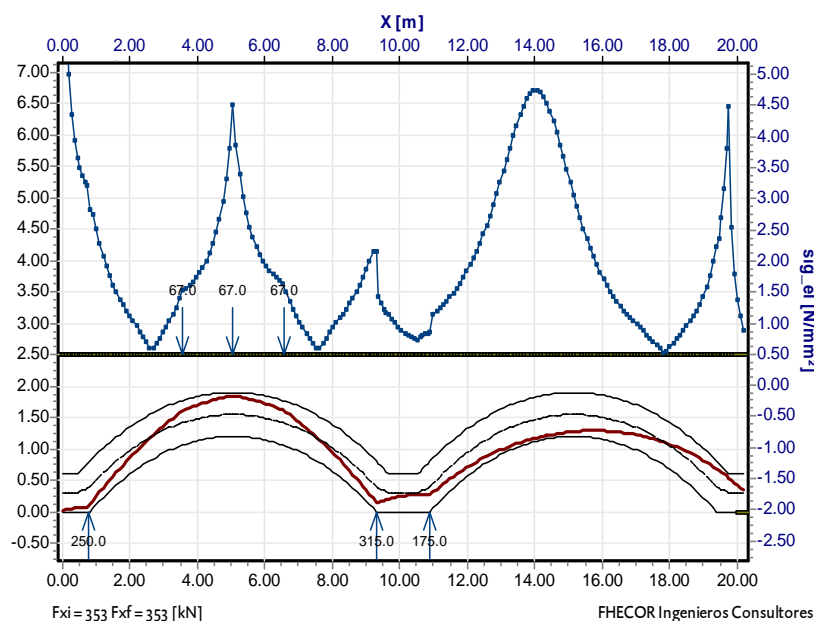
Fig. 5. Analysis of the bridge with a second level tool

The structural analysis was carried out by means of a second level tool developed by the second author<sup>1</sup>: a thrust line calculation with control of internal forces and their comparison with a  $N$ - $M$ - $V$  interaction diagram according to the criterion of Mann-Müller, which was considered suitable enough for this purpose. Figure 5 shows one of the calculations, where special attention must be paid to the intermediate pier between two adjacent vaults. The total reaction is splitted into two forces, each located at the external sheets of the pier. This is more realistic and, simultaneously, more efficient, counteracting the moment on the pier by the different thrusts of vaults due to non-uniform live load.

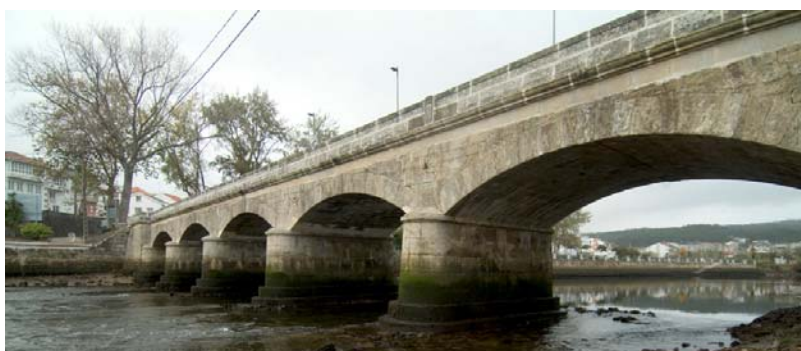
Fig. 14. Downstream appearance of the bridge once the works were completed.

Figures 14 and 15 show different views of the completed structure. Indeed, the downstream elevation recovered its primitive appearance, as required, and the upstream elevation showed relative minor influence of the RC slab due to the reduced value of the protruding length and the presence of the galvanised steel grid for the pedestrians' sidewalk. It is worth mentioning how the presence of ducts (phone, electricity wires) spoils the appearance of the bridge much more than the RC slab and the pedestrians' sidewalk.

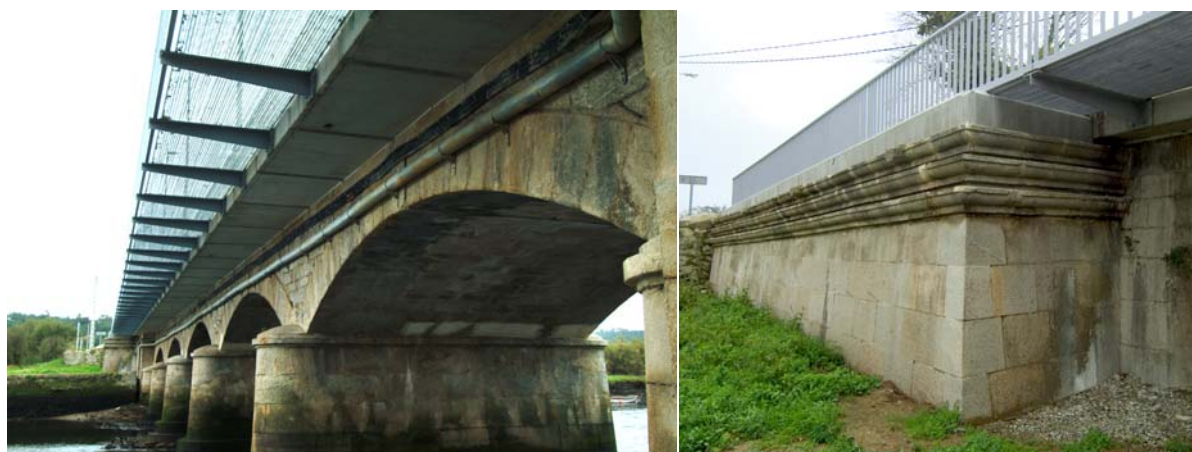
Fig. 15. Upstream appearance of the bridge once the works were completed (left). East-south wall, renewed in stone and completed keeping the cornices of the upstream elevation in order to guarantee the reversibility of the intervention by using exactly the same units of the bridge.
